Robert L. Swaim  
Systems Group Chairman

***National Transportation Safety Board***  
Investigations Into Trans World Airlines Flight 800

### From TWA 800:

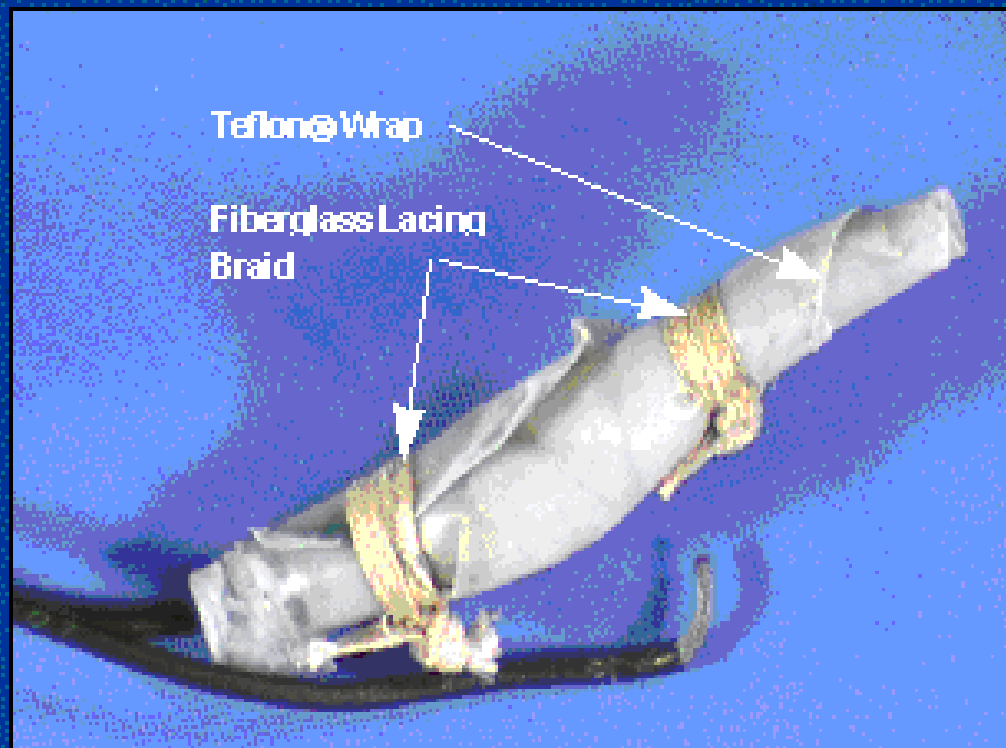
## Improper Wire Repair From TWA 800 Wing Fuel Tanks

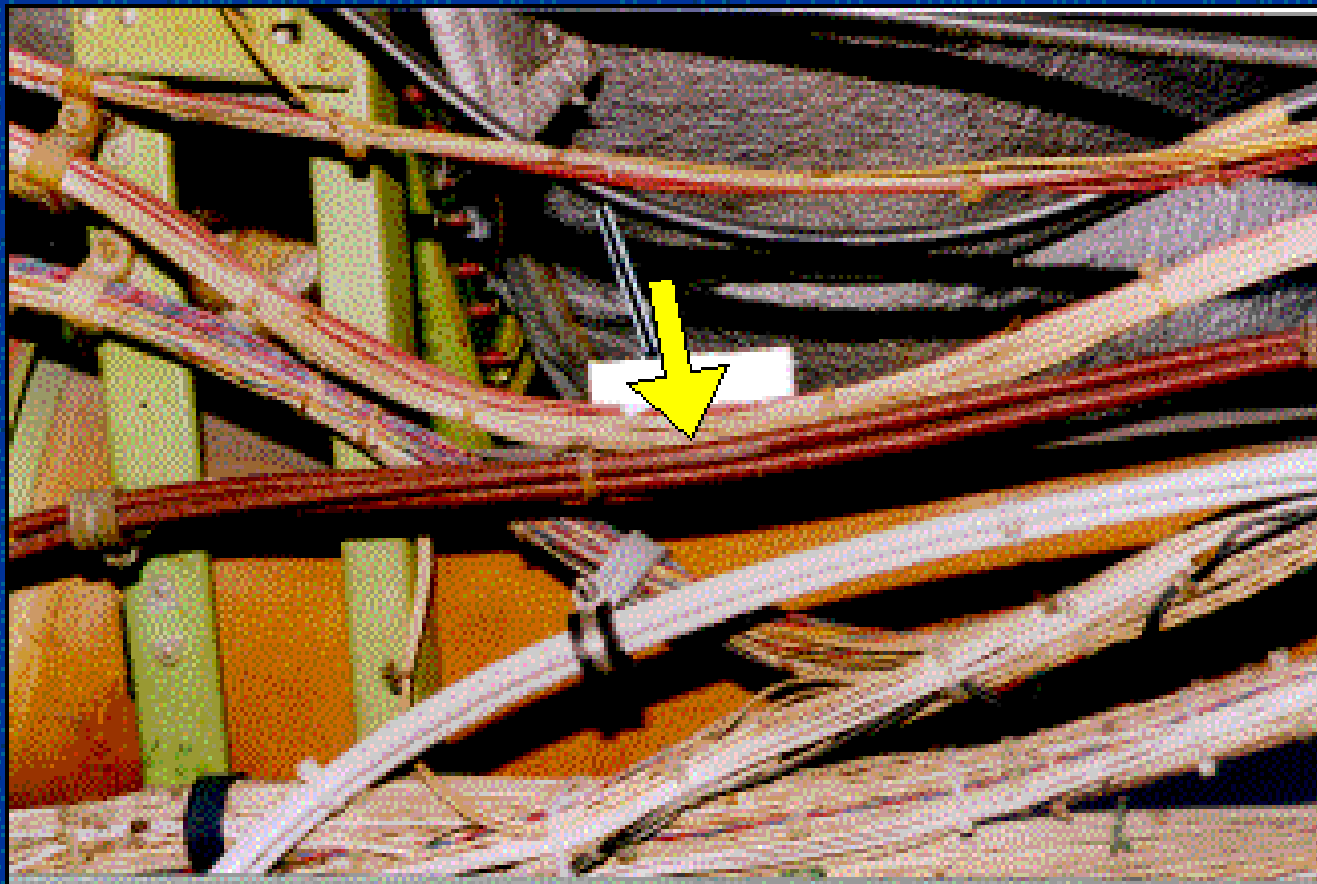
## Chafe of Fuel Gauge and Galley Power Wires (747)

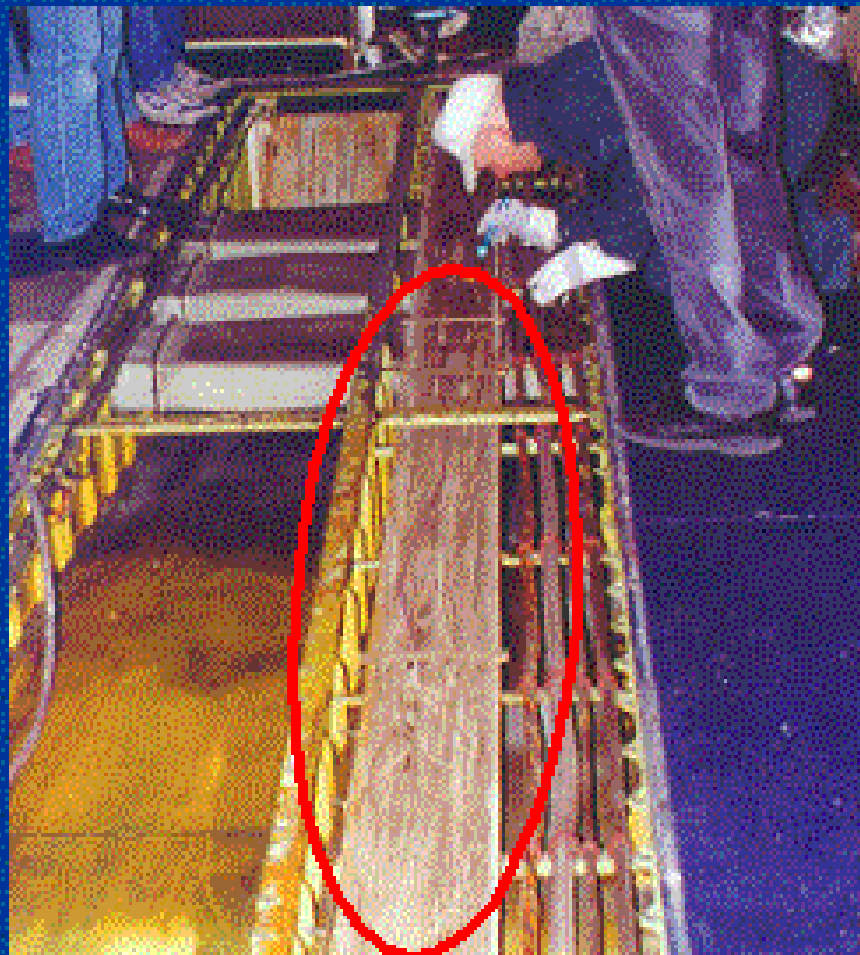
## Wires Loose in Tray (747)

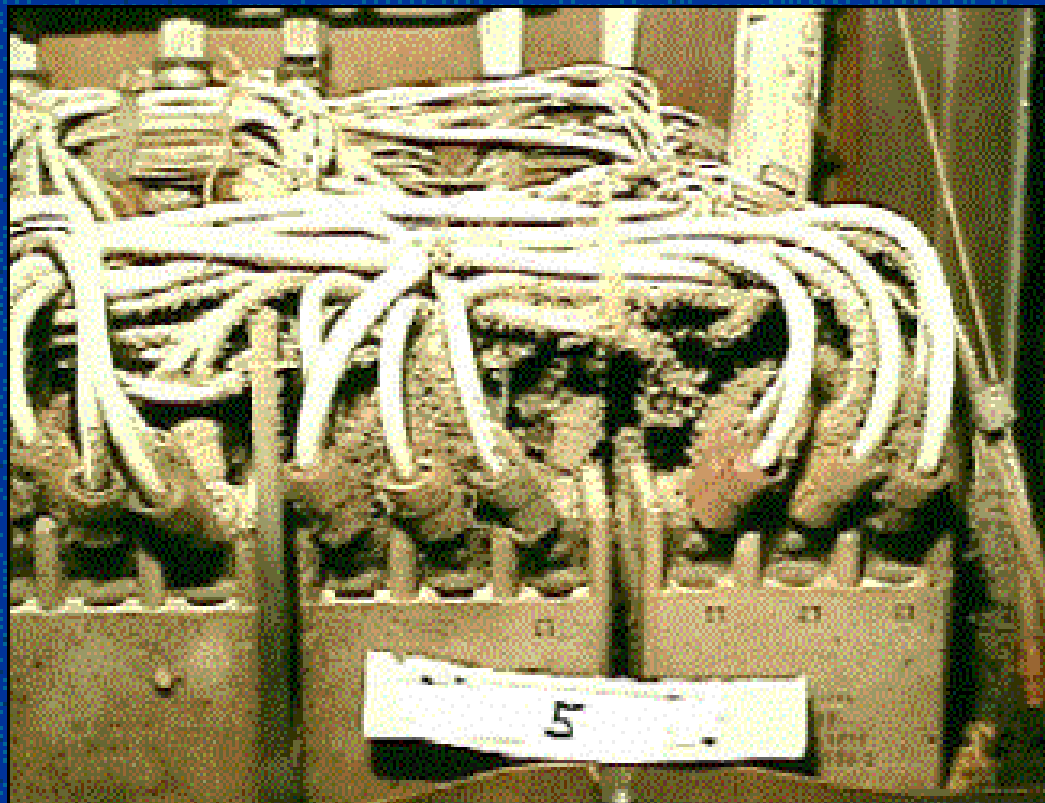
### Lint in Circuit Breaker Panel (A300)

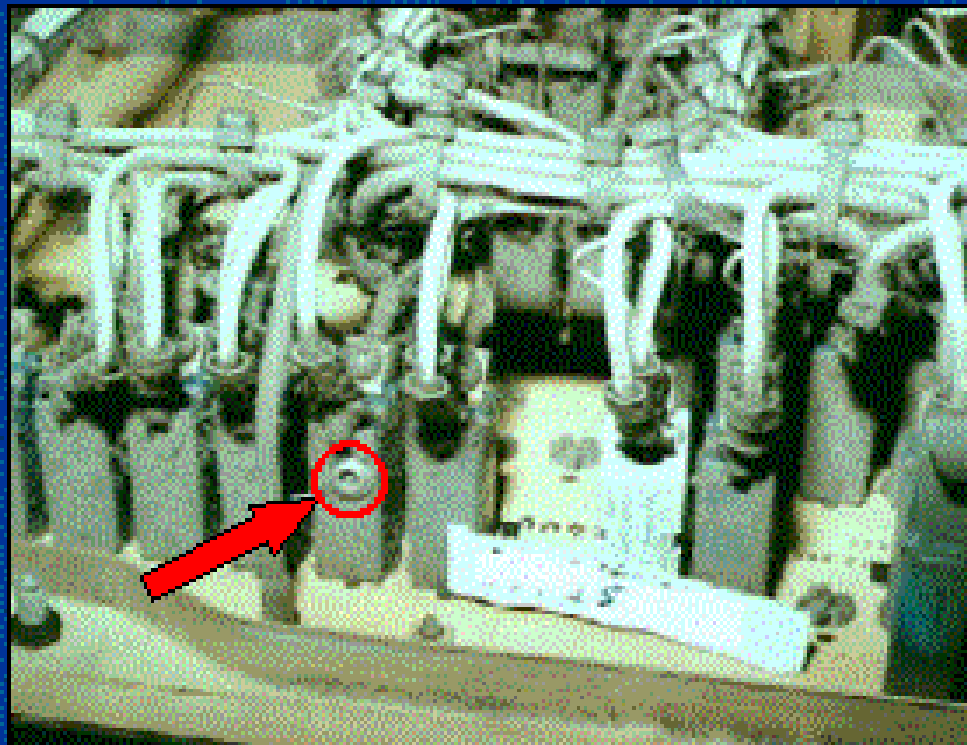
## Steel Washer On Circuit Breakers (A300)

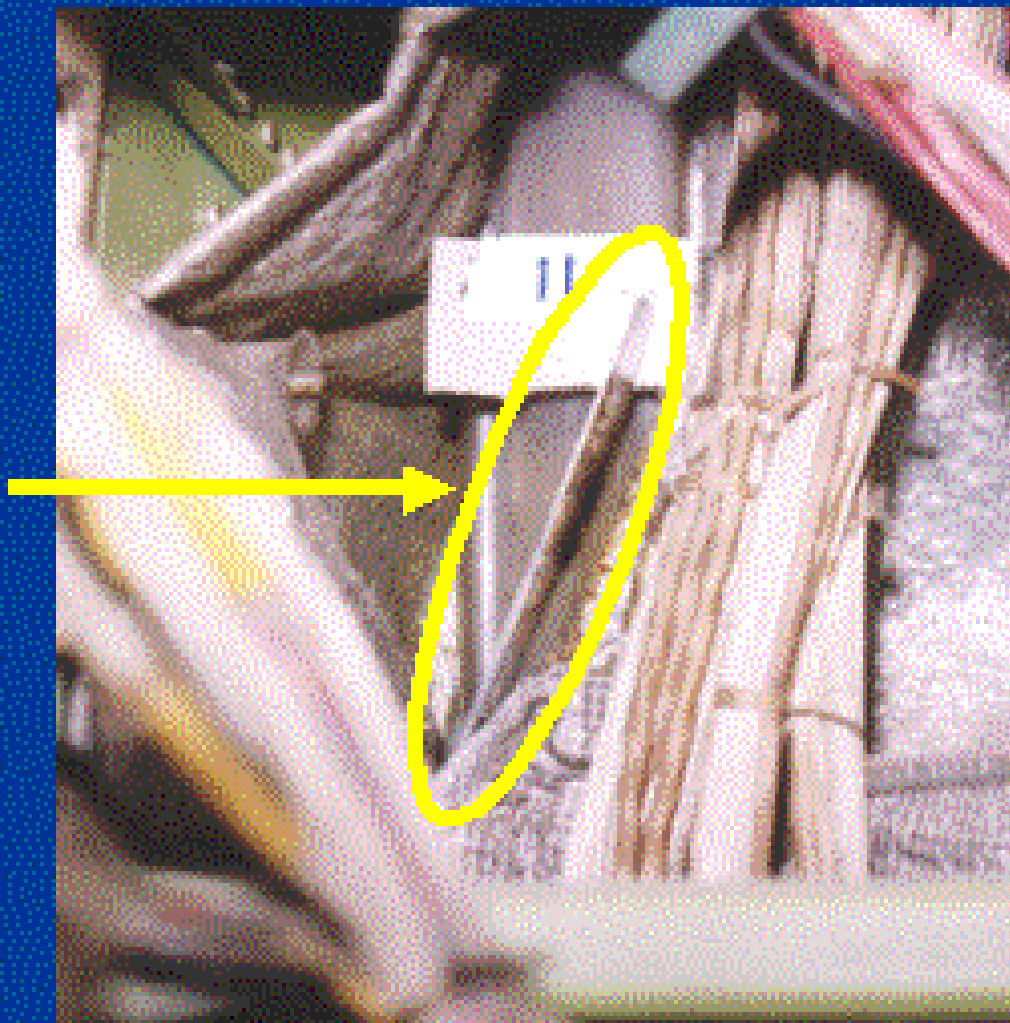
## Non-Aircraft Hardware Near Wiring (747)

Dinner  
Knife

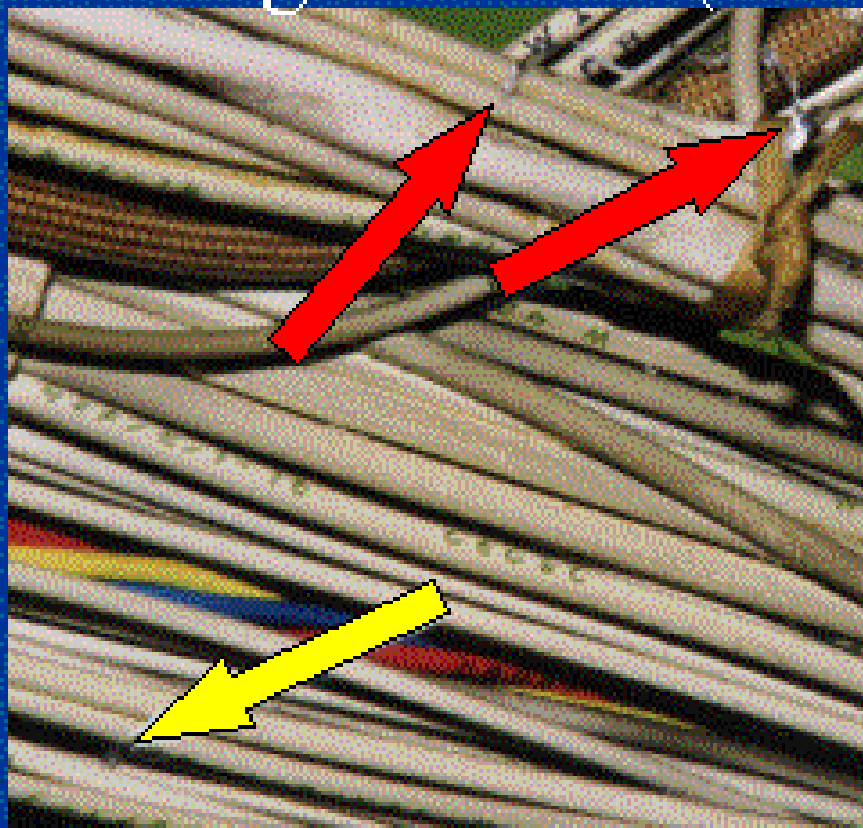
# Shavings On Top Of Wires And Coming Through Bundle (747)

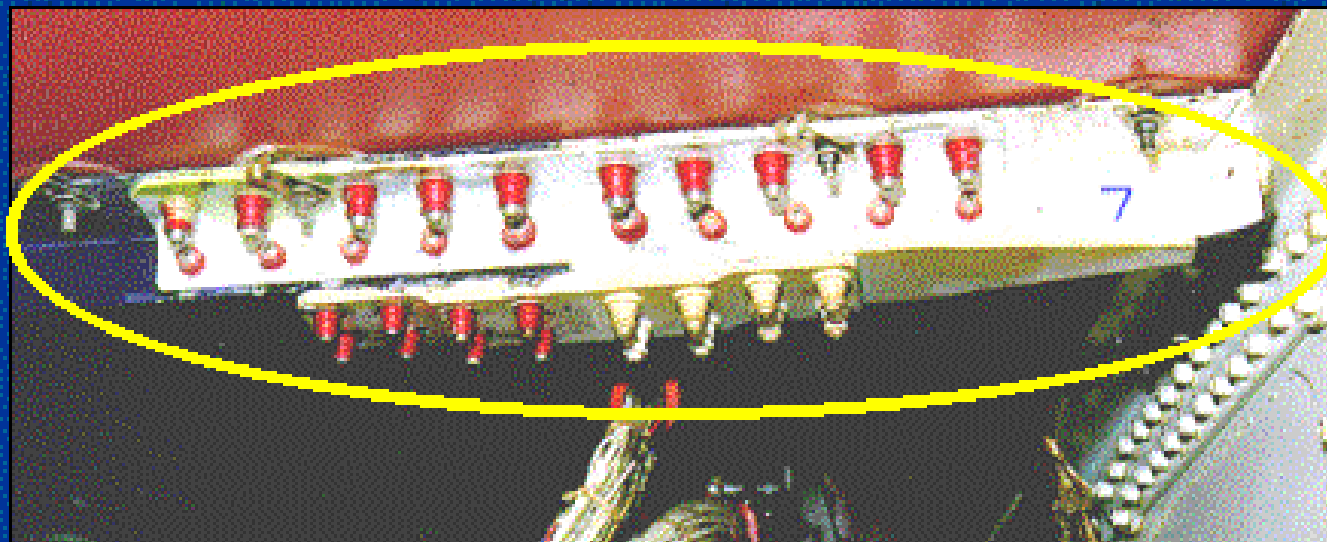
## Structural Repair Above Metal Shavings On Wires (747)

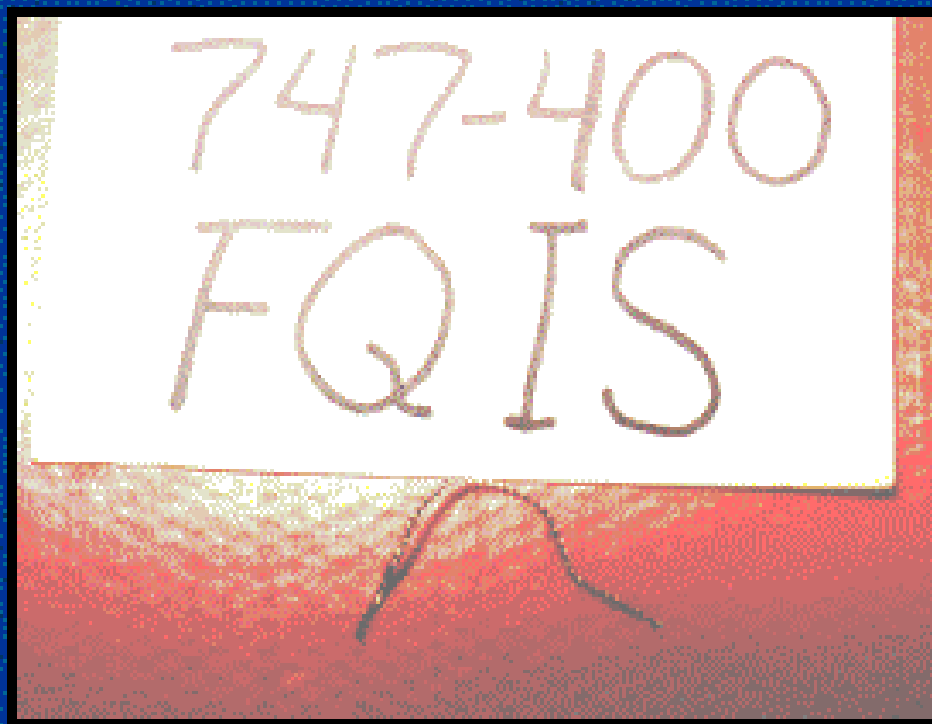
## Drill Shaving In New Airplane (747-400)

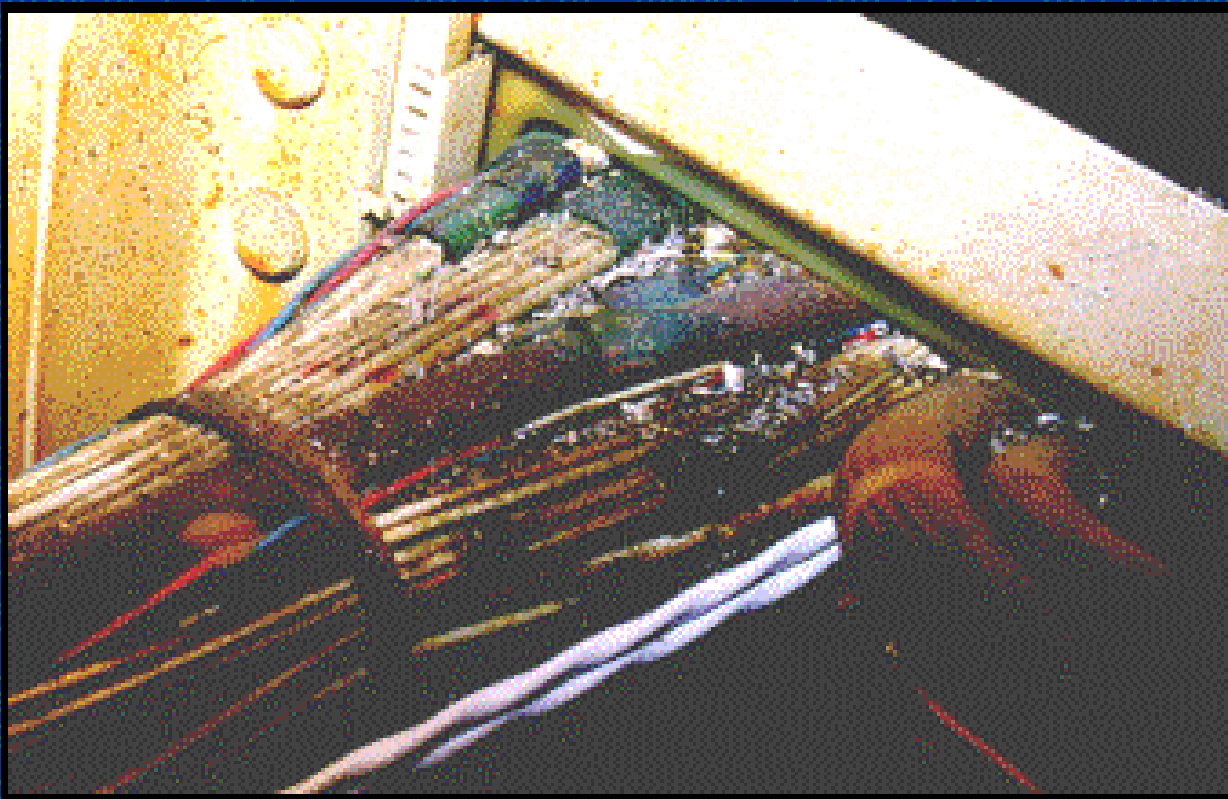
## **Drill Shaving And Fluid Contamination (747)**

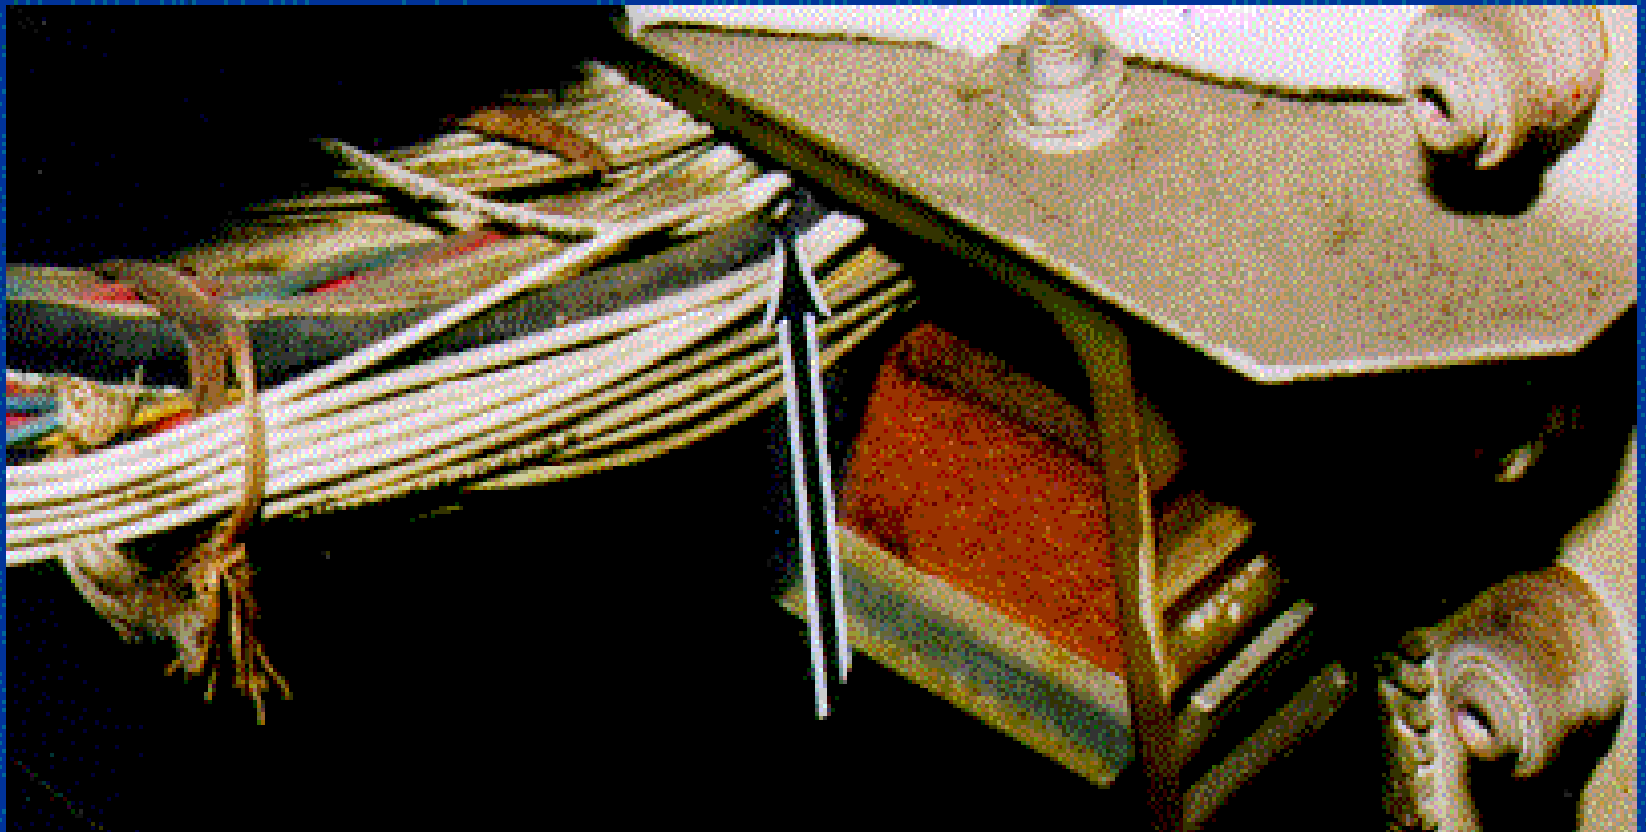
## **WIRES CAN NOT BE VISIBLY INSPECTED**

**HOLE WORN THROUGH PROTECTION (747)**

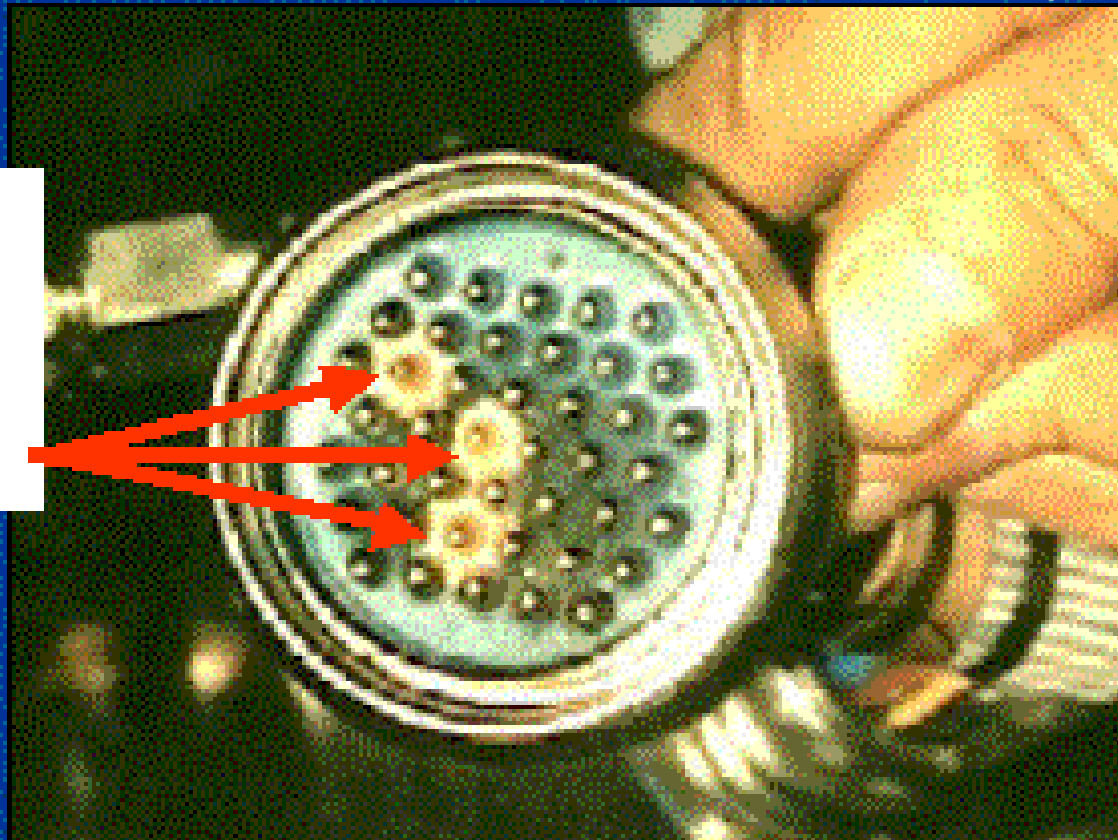
## Hydraulic Fluid In Connector (747)

Damage  
To Rubber  
Grommet

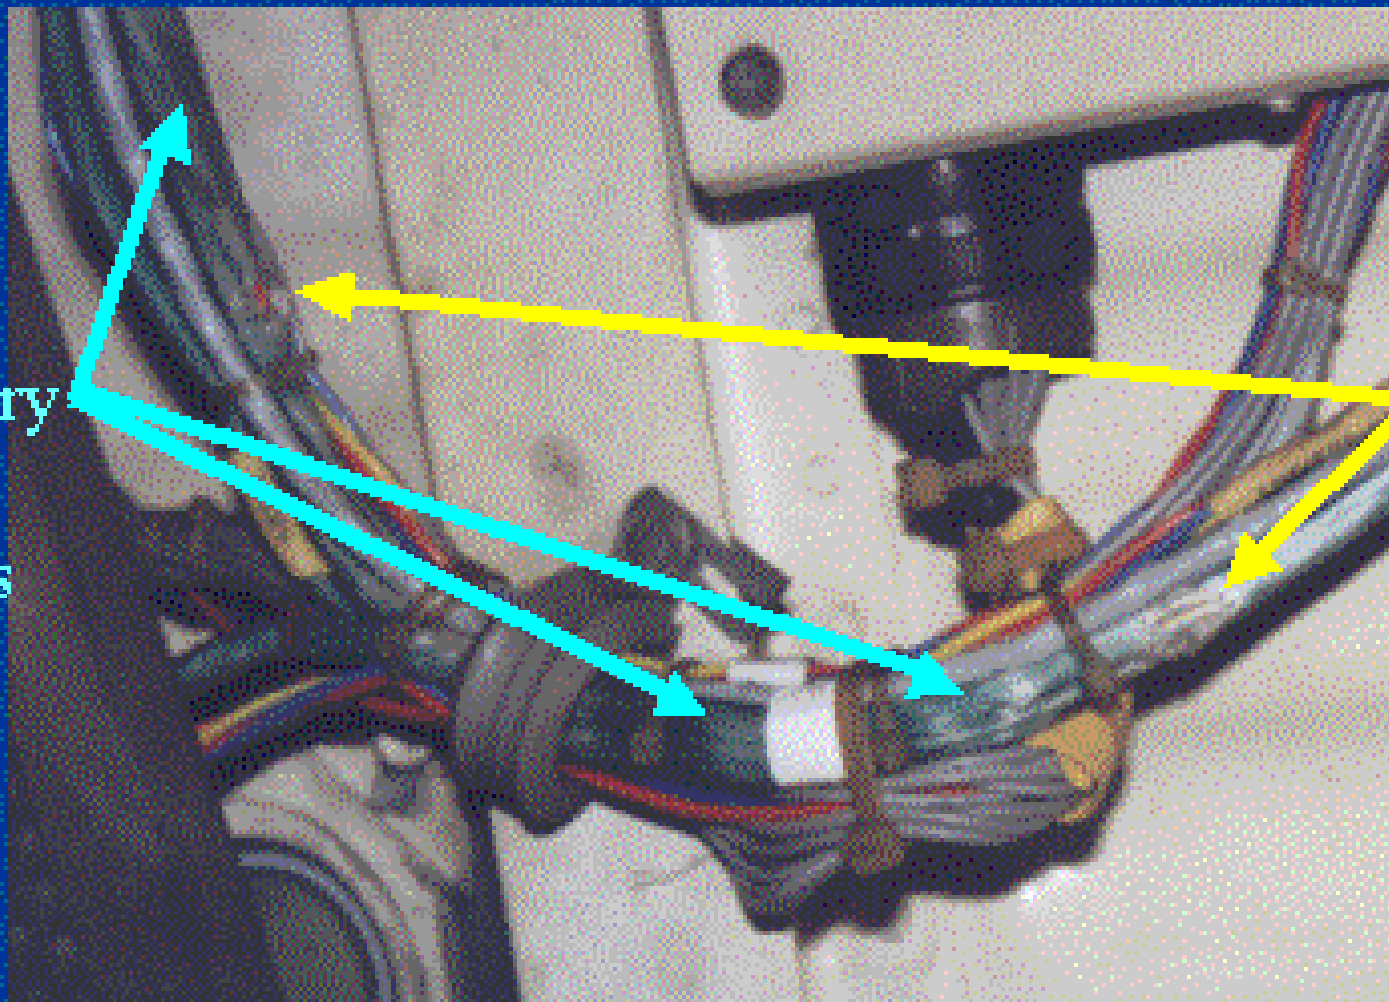
## Lavatory Fluid Stains (737)

Blue  
Lavatory  
Fluid  
Stains

Damaged  
Wire  
Sleeves

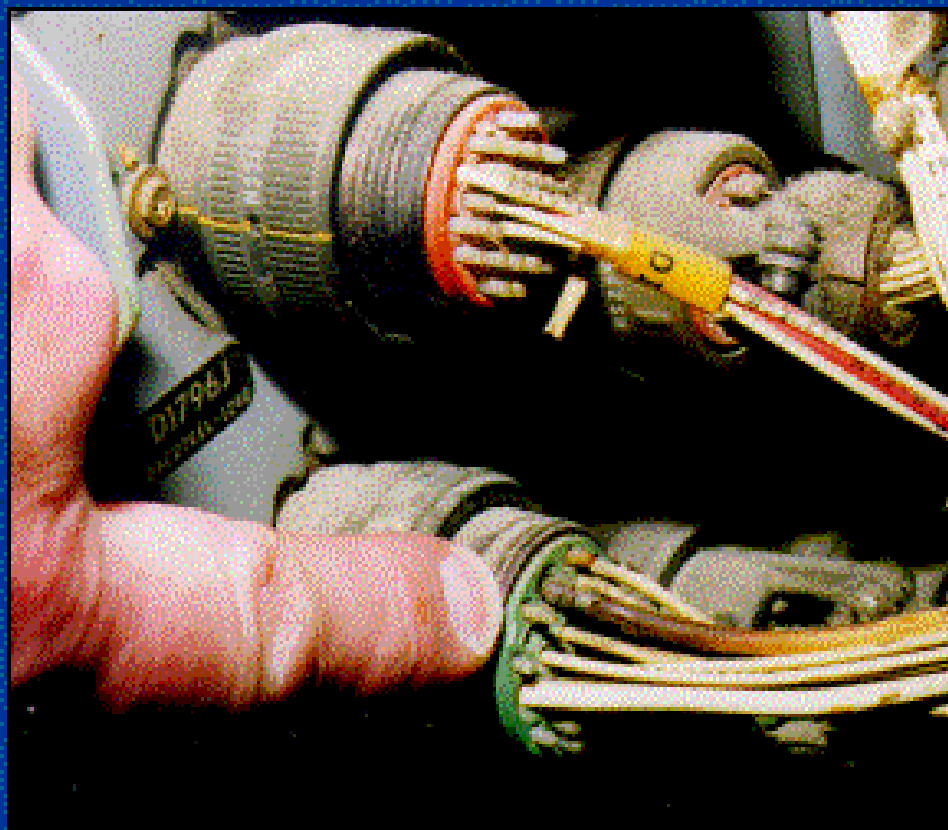
## Overheated Connector Pins (747)

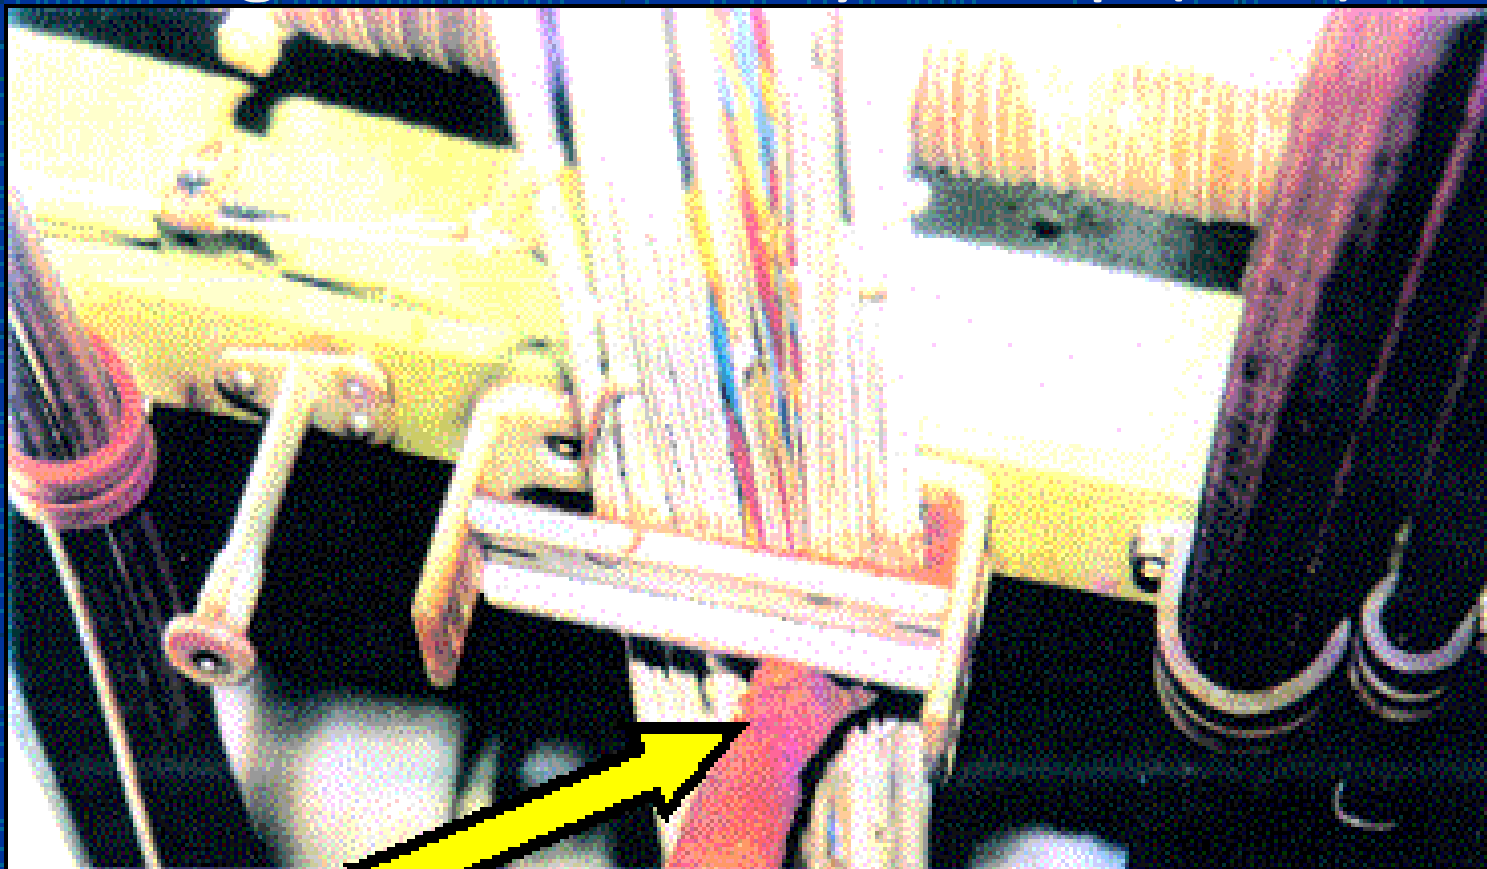
## Degraded Raceway Clamp (747)

Degraded foam hanging from clamp

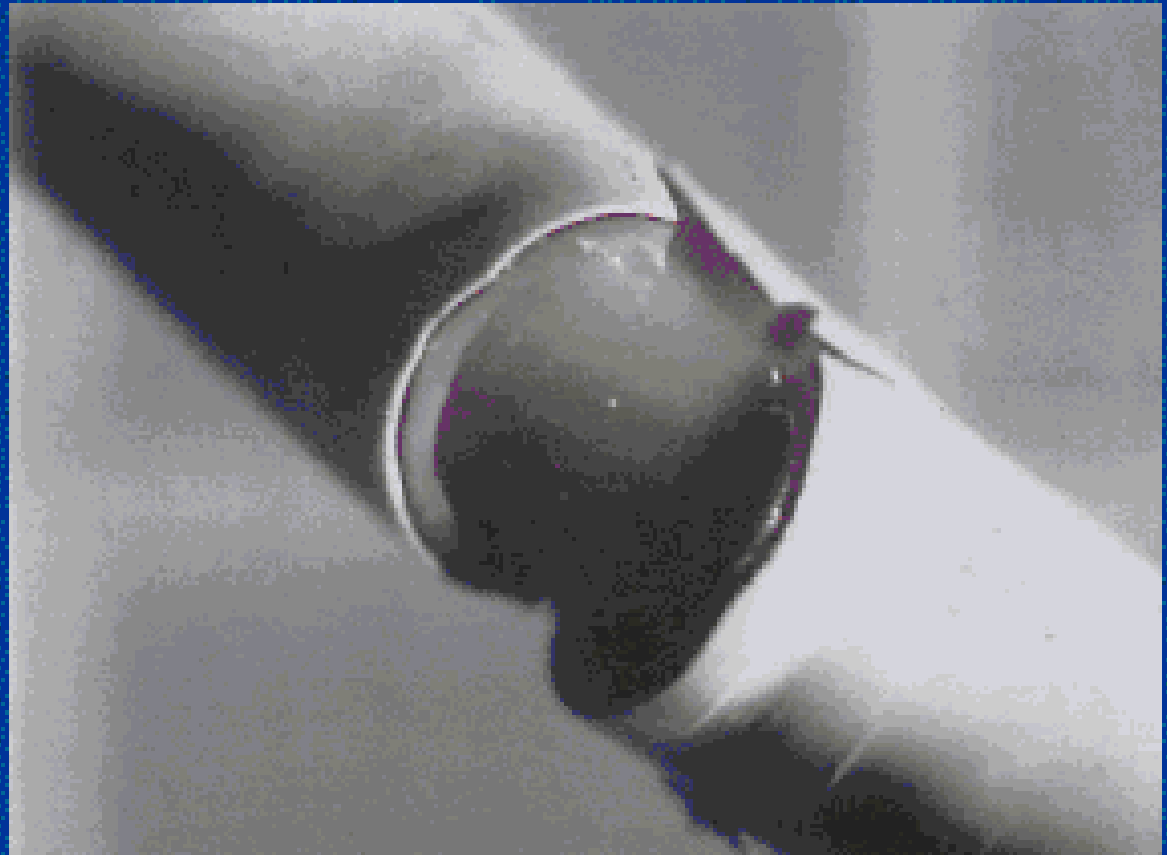
Photo shows inner  
insulation layer is intact  
and copper is not  
exposed

Raytheon caption: "Wire cracked  
after gentle handling"
